Welcome to October/November Newsletter from SKIPPER Electronics!

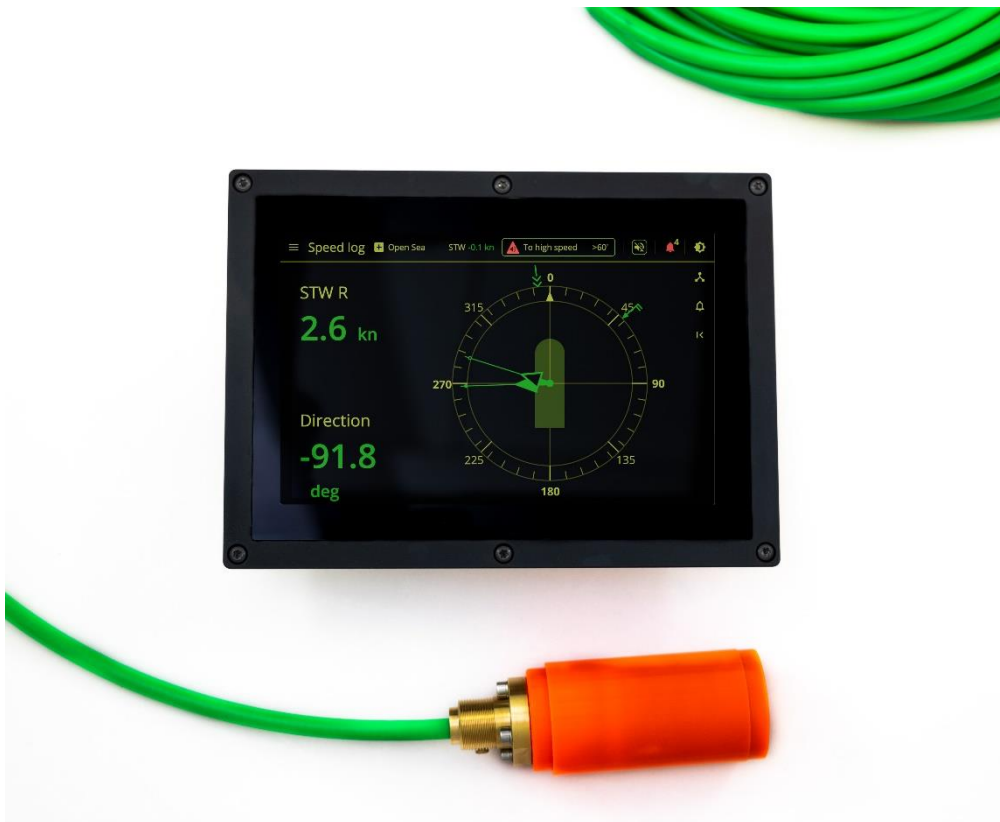
The current 9" displays will be replaced in the next few years by a new 10.1" display. We therefore recommend that when designing bridge consoles for these displays, extra room is left for later replacements or service.

The space allowed should now be at least 300x220mm

We have updated the mounting spec in manuals and datasheets to reflect this, these can be downloaded from the webpage.
